**Tom Mazzacavallo and Ed Kuenz,**  
**Nalco Water, an Ecolab Company,**  
analyse how digital technology provides  
producers with real-time visibility,  
enabling them to stay ahead of fouling,  
scaling, and corrosion in their facilities.

# DRIVING PERFORMANCE WITH DIGITAL INSIGHTS

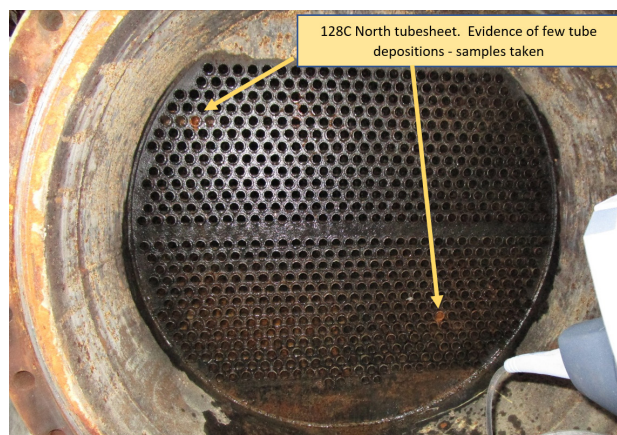
**Figure 1.** 128°C tube sheet from an ammonia plant inspection showing a hard deposit restricting the flow and heat transfer within the unit.

to unplanned downtime. For example, mineral scale precipitates at higher temperatures, creating an insulation layer that reduces heat transfer across the exchanger (see Figure 1 for an example of hard mineral scale deposits).

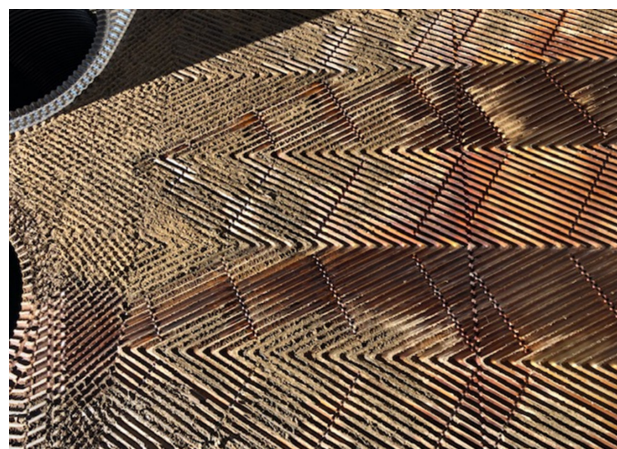
**Figure 2.** Plate from a heat exchanger taken apart during an ammonia production downturn. The grooves on the top of the plate are covered with a biofilm, adding a layer of thermal insulation.

As another example, biofouling can reduce heat transfer efficiency even more than a layer of mineral scale of the same thickness due to lower thermal conductance. Biofouling occurs when microbial growth in the bulk water attaches itself to the surfaces in the system and creates a film. Once attached, the biofilm starts to mature, attaching itself more firmly as it grows (see Figure 2). Biofilm creates an environment for under-deposit corrosion, which shortens the life of a heat exchanger.

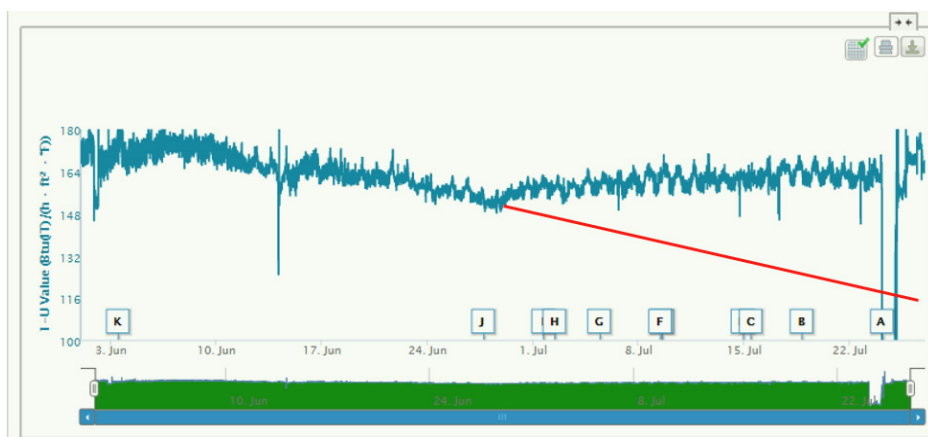
**Figure 3.** Graph of the U-value of the MEA cooler over time. After the trend was realised, chemical adjustments were made that helped recover efficiency.

Subsequently, Nalco Water deployed Ecolab® Heat Exchanger IQ™, a digital solution that continuously trends U-value, a valuable indicator of heat transfer efficiency, through measurement of water flow and multiple water and process temperatures. Four weeks after a baseline was set, the U-value showed a slow, but consistent decrease (see Figure 3).

By collaborating with the plant's water treatment team to analyse chemistry indicators, Nalco Water determined that microbial activity was at the root of the issue. Summer water temperatures and higher suspended solids in the makeup water increased biocide demand. Operators adjusted the programme to account for the variability, and the U-value recovered completely within a few weeks. The plant avoided US\$150 000 for every day of production loss that would have been experienced if premature offline cleaning would have been required.
